October 7, 2021 (Draft)
November 12, 2021 (Final)

**Re.: Building Condition Assessment
Huntington Memorial Library
62 Chestnut Street
Oneonta, NY 13820**

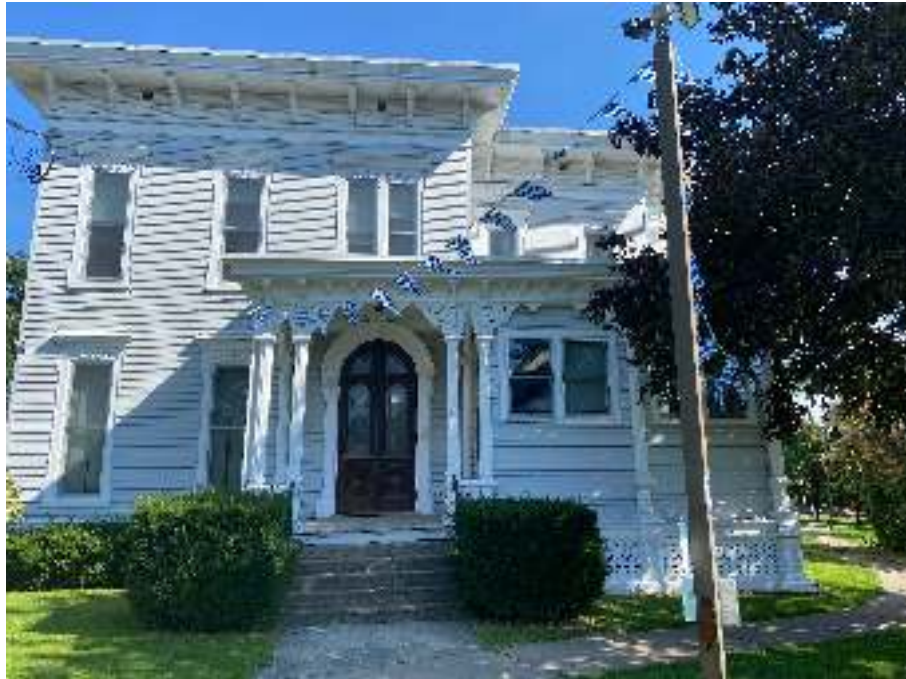
Photo 1

The Library building is located on the property with its original primary façade facing essentially due south. The Library is sited within a public park and as such, offers a pleasant setting with generous lawn areas, walkways and mature trees. Some of the shrubs and plantings closer to the building have become somewhat overgrown. Concrete sidewalks are in fair to good condition. There is a stone retaining wall with concrete steps located at the south-east corner. The retaining wall appears stable and is generally in good condition. Some of the rope-style mortar joints are in need of repointing and the steps show evidence of past settlement. The joints and settlement issues should be monitored seasonally for potential worsening and repaired when possible. There is limited parking on the primary Library site with additional parking available in a public lot to the north. The layout of the on-site parking is such that the Library building is vulnerable to being struck by vehicles. [See Photo 2 below]

SOUTH ELEVATION

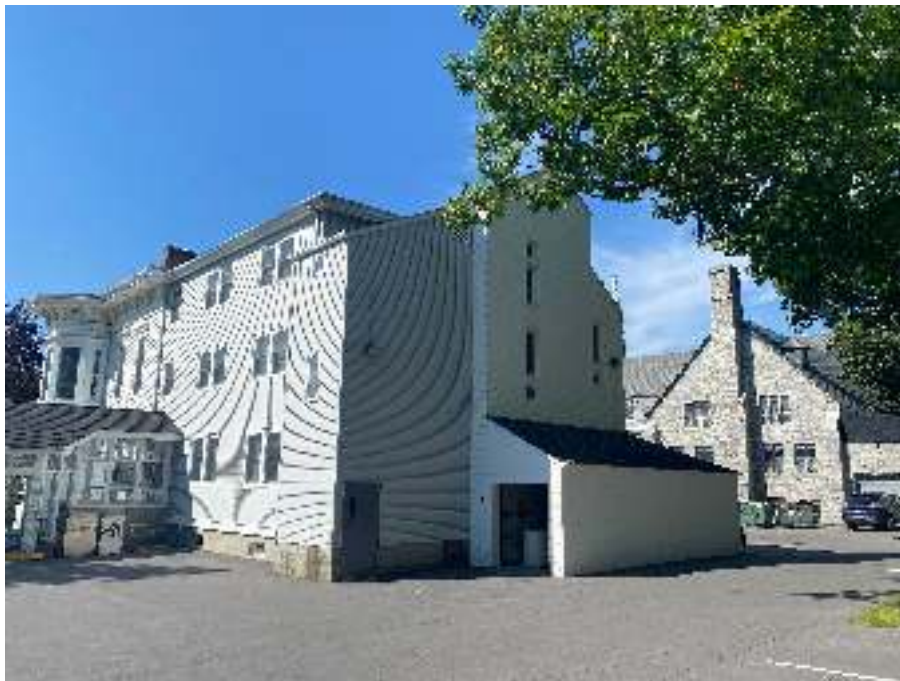
Photo 2

VIEW FROM ON-SITE PARKING

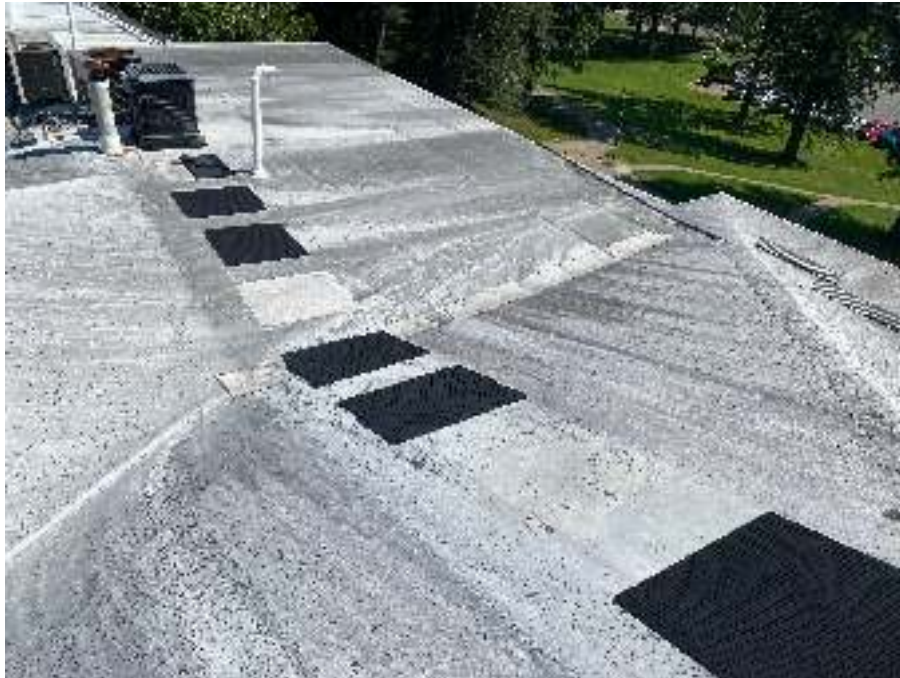
The main roof of the Library, including the original building and northerly additions is a white, single ply membrane that appears to be Hypalon®. This roofing appears to be at least twenty years of age and as such, is nearing the end of its expected life span. While no active leaks have been reported, plans to replace this roof should be made within the next three to five years. There are a number of snow retention “fences” adhered to the membrane which were likely added after the roof was in place. Hypalon® and other single ply membranes are prone to allowing snow and ice to migrate and slide off, creating a hazard to pedestrians and vehicles below. Similar protection will be needed when the roof is replaced.

Photo 3 MAIN ROOF LOOKING ±NORTH

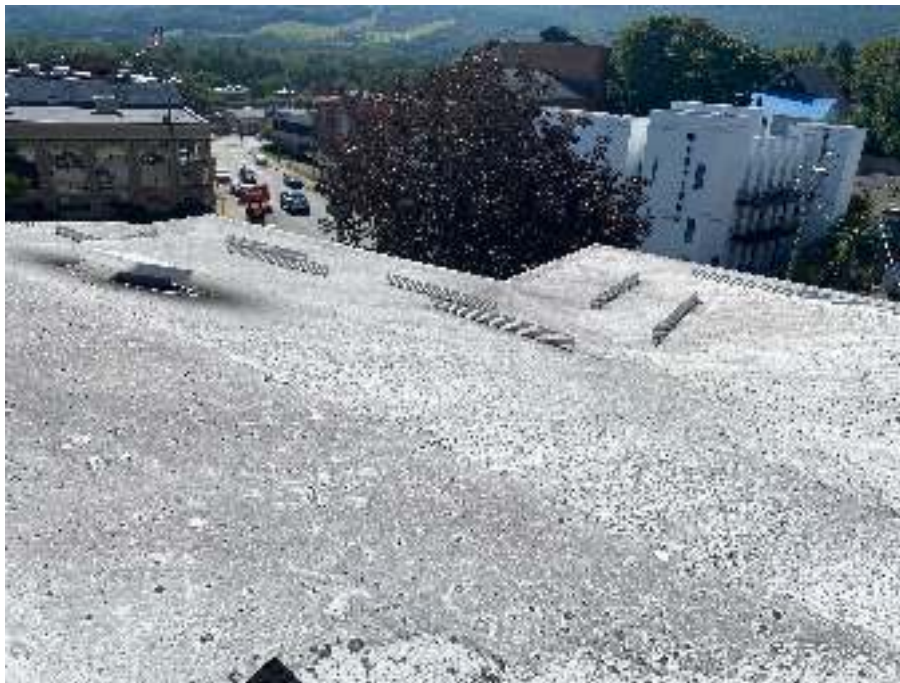
Photo 4 MAIN ROOF LOOKING ±SOUTH

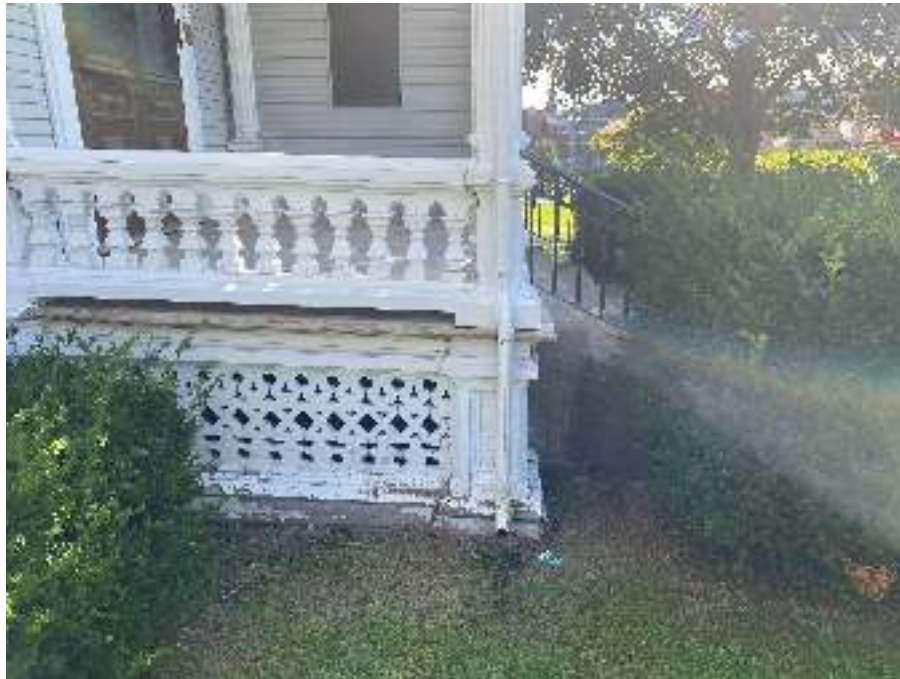
Photo 5

The remaining wood trims, columns, lattice work are in need of scraping and painting. Some of the wood trims and lattice work, especially at the original front entry porch are quite deteriorated and in need of repair/replacement. Of particular concern is the south-west column of the porch. There is significant sagging evident in the porch floor. The source of the sagging could be deteriorating foundation/pier or rotting of a wood column. It is recommended that a skilled carpenter be hired to partially dismantle the wood trims in this area so that the internal structure and foundation of this area of the porch can be further evaluated by a qualified structural engineer.

FRONT PORCH COLUMN

- 1) Structural analysis of original front porch**; \$2,500 - \$3,000 (structural engineer)+ \$3,500 (carpenter)

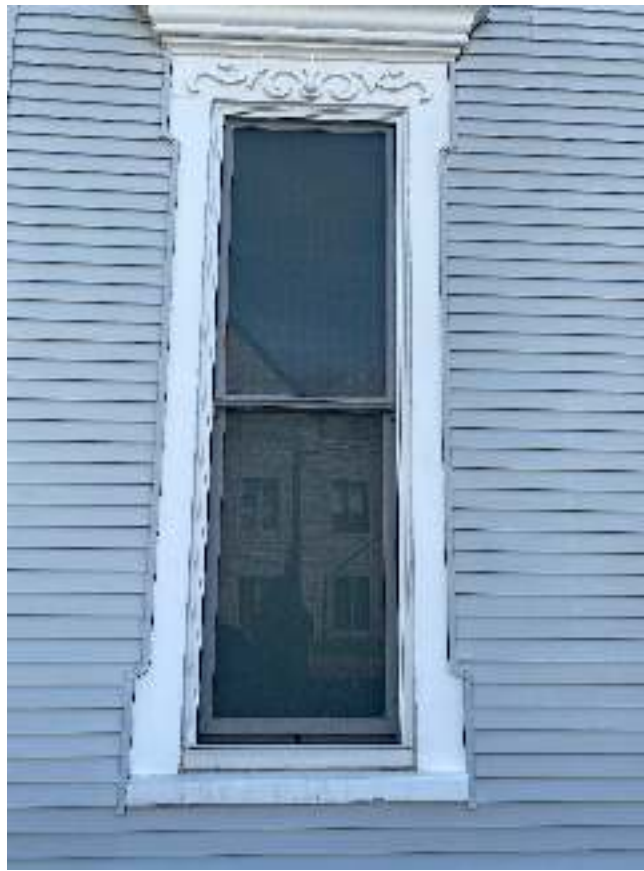
Photo 6

The majority of the windows of the building are aluminum clad wood replacement units with insulated glazing. They are a fairly good quality window and are in good condition. Most of the windows are operable double hung units. There are fixed and casement windows in the elevator tower addition. It is worth noting that in many locations, the sills of the windows are lower than eighteen inches above the floor. The Building Code requires windows with the bottom edge of the glass eighteen inches or lower to the floor must have tempered safety glass. The etched label visible on the units does not appear to indicate the glass as being tempered. There are films available that can be applied to existing glass to allow the glass to be considered safety glass. In addition, BRMA's standard for operable windows that are close to the floor is to have a window opening control device to prohibits the window from opening more than four inches. There are retrofit kits available for this purpose. A skilled glazing contractor could be brought in to provide these services.

TYPICAL WINDOW

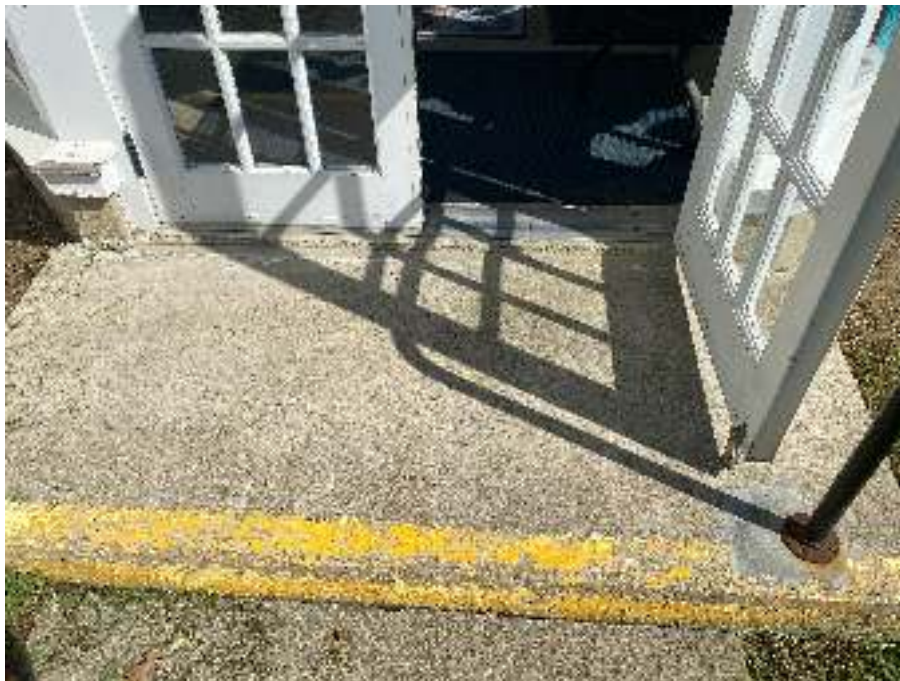
Photo 4

The Main Entry to the Library is through a gazebo-like addition on the east side of the building. While it is functionally adequate, it does have some shortcomings which are difficult, if not infeasible, to correct. There are two pairs of thirty inch wide doors at the north and south sides of the gazebo each of which have one "active" and one "inactive" leaf. The Building Code requires a thirty-two inch minimum clear opening for an egress door. The same width shortcoming exists at the exit doors out of the Library going into the gazebo exit. In addition, there is a single step from the slab-on-grade of the gazebo to the paved parking surface to the north and to the sidewalk leading away from the south side exit. This represents a trip hazard, which is marginally addressed by the addition of steel pipe guard rails outside the doors. Furthermore, the thresholds of the doors themselves have an approximately one inch high lip which can also be a trip hazard.

SOUTH GAZEBO EXIT/ENTRY

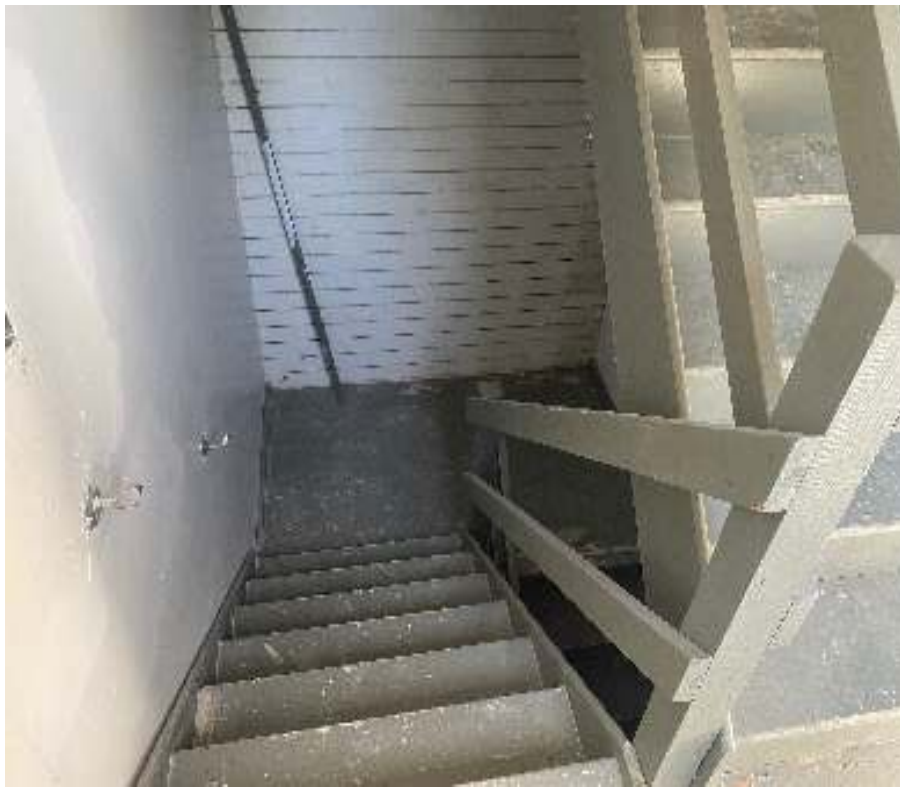
Photo 8

The handicap accessible entrance, while not ideally located as stated earlier, is in good condition and functions well. The emergency exit stair at the north end of the building, while functional, contains several Building Code issues. To begin, the stair does not function as a handicap accessible path of egress. To function as such, each floor level requires an area of refuge to allow a wheelchair-bound person to wait for emergency personnel assistance without impeding the exit path. The area of refuge also requires a two-way communication device. In addition, the stair does not meet the minimum forty-eight inch clearance between the handrails. Furthermore, the current handrails are not code compliant in several ways. They are not continuous, they do not return to the walls, they do not meet the minimum height requirements, they do not have balusters or other means to prevent the passage of a four inch sphere, nor do they have the required top and bottom extensions. In addition, one handrail is currently detached from the wall.

NORTH EXIT STAIR

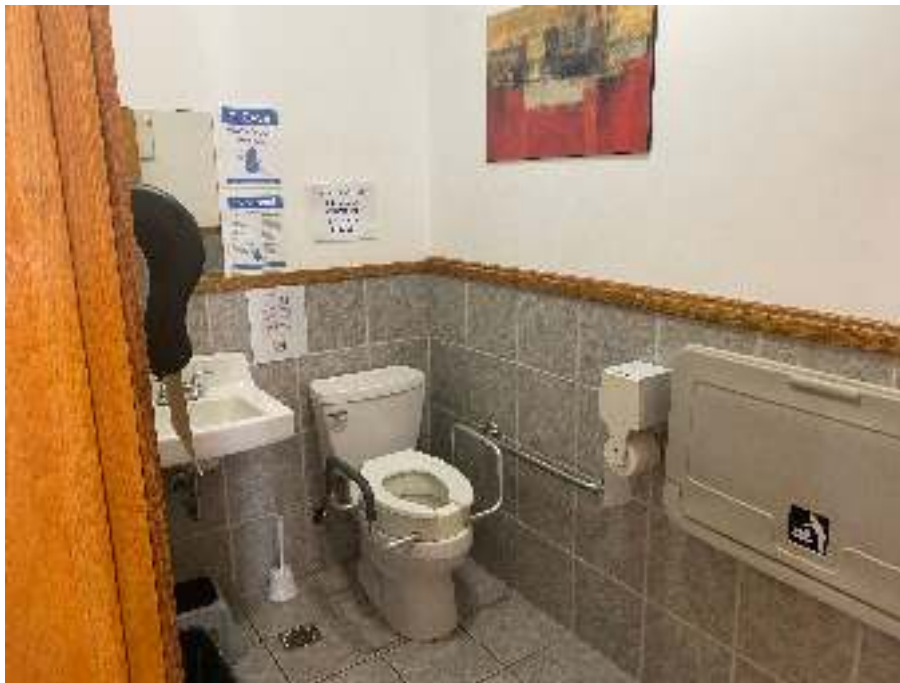
Photo 9

Handicap Accessibility: Vertical accessibility to all floor levels of the building, including the basement but not the attic, is accomplished via the elevator. No issues with the elevator have been reported. The Main Floor restrooms have handicap accessible improvements, but they are not considered fully accessible. The rooms lack some required grab bars and accessible accessories. Lavatory piping is not insulated and the minimum accessible turn radius space is inadequate. The Staff restroom on the second floor is not accessible. There is no accessible height counterspace for Staff or Patrons at the Main Circ Desk. Stacks and other furnishings or contents impede minimum clearances and some stacks exceed the maximum overhead reach heights.

MAIN FLOOR RESTROOM

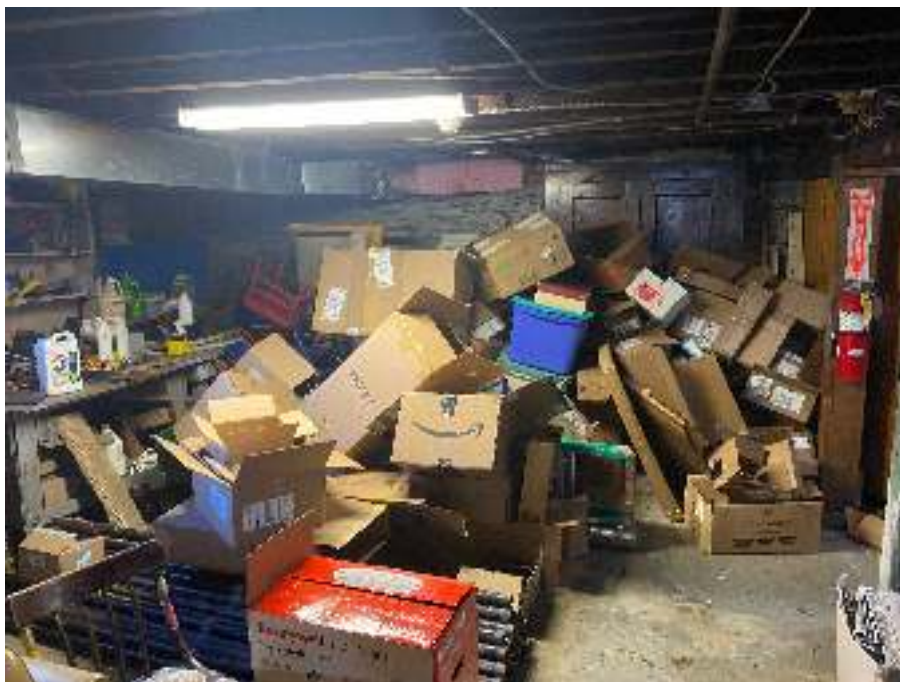
Photo 10

Basement Area: The basement of the building is primarily unoccupied storage space that is inundated with stored contents and debris. Most of these materials could be sorted through and disposed of, if of no value. Much of the materials are combustible in nature and represent fire hazard. At a minimum, stored materials that block and prohibit adequate clearances in front of the electrical panels as required by code, should be eliminated or relocated. A portion of the basement serves as a workshop area for the building's maintenance person. It too is somewhat overwhelmed with stored materials, tools and equipment, much of which could also be eliminated. Mechanical equipment is also located in the basement as well as the elevator machine room. Please see the separate report by Sage Engineering for information regarding the mechanical equipment.

BASEMENT

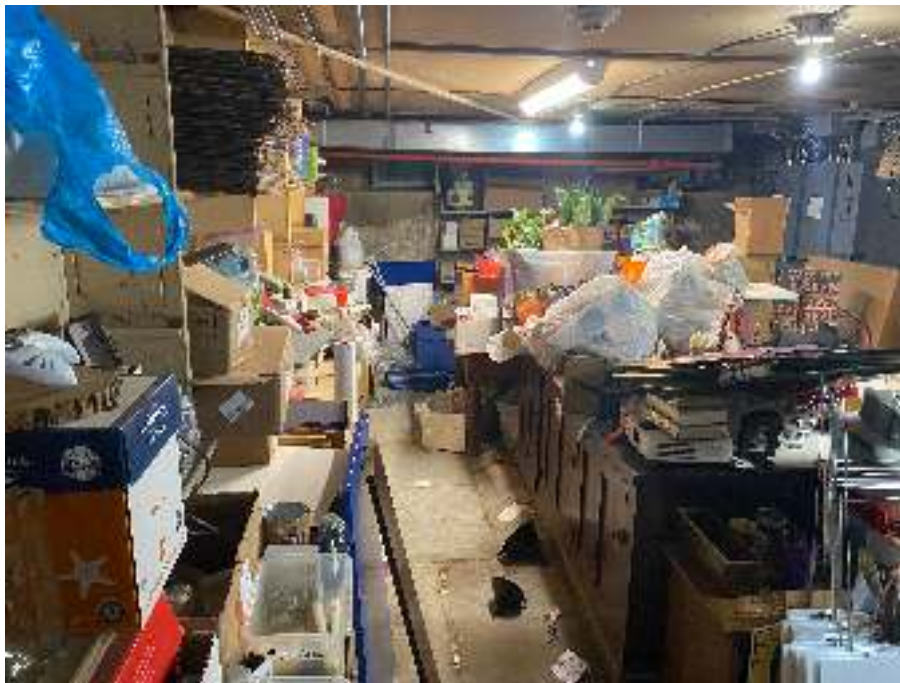
Photo 11

BASEMENT [Note blocked electrical panels]

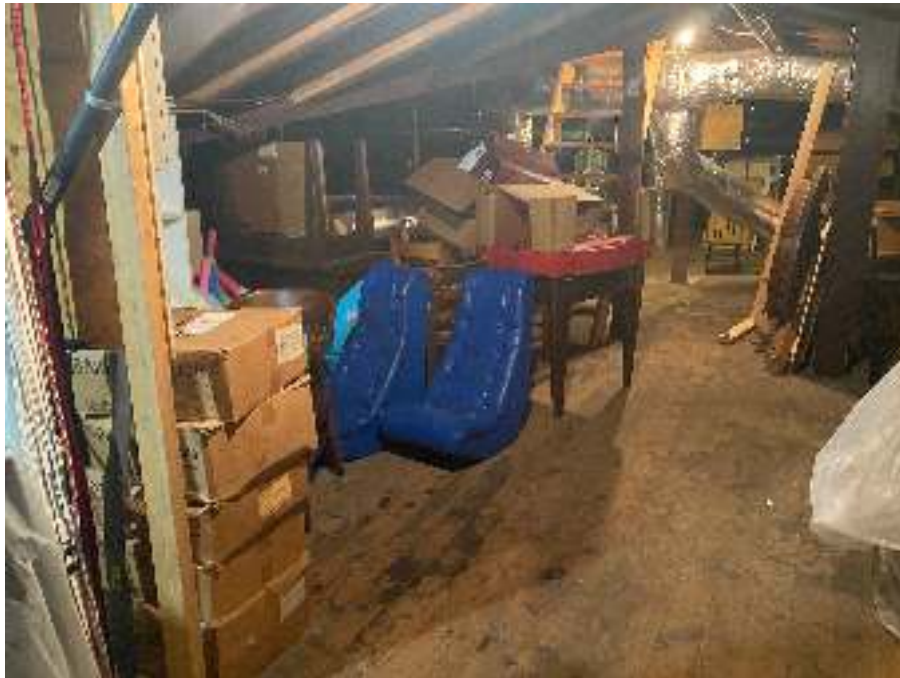
Photo 12

Attic Area: The attic is accessed via a steep stair from the second floor. The attic is also loaded with stored contents and debris which should be sorted through and disposed of, if of no value. There is even some abandoned mechanical equipment in the attic that could be removed.

ATTIC
